## User Advisory

### Air Mask Audi-Larm™ Coupling Nut Tightness

December 12, 2008

PPL08035-01

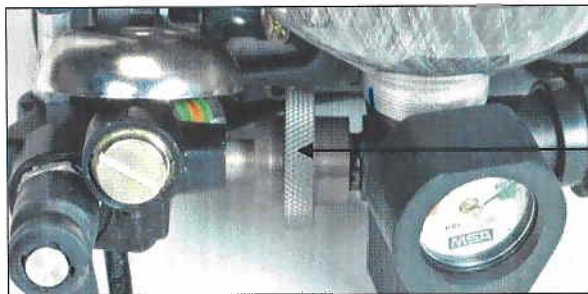
Audi-Larm™  
Coupling Nut

MSA recently received reports of the release of high pressure air from the Audi-Larm coupling nut joint. The Audi-Larm coupling nut secures the Audi-Larm assembly to the cylinder valve. This joint employs an o-ring seal with a hand tightened coupling nut. Some of the reports indicated that the o-ring extruded and the air loss occurred several minutes after the cylinder valve was opened and the air mask pressurized. Our investigation into these occurrences indicates that the coupling nut was not hand tight before use. An Audi-Larm coupling nut that is not hand tight can cause unexpected extrusion of the coupling nut o-ring and potentially result in a rapid loss of air.

The design of the coupling nut joint allows the o-ring to compress before metal to metal contact prevents further tightening of the coupling nut. Thus, the user can readily determine whether the coupling nut is tight or loose. In addition, sufficient resistance to turning the coupling nut prevents inadvertent loosening.

**Users must ensure that the coupling nut is hand tight when donning the air mask before each use. Also, users must ensure that the coupling nut is hand tight during air mask inspections and before performing any functional tests. It is important to include these steps in the routine air mask use procedures. We are reinforcing these checks in the operation instructions as a reminder of the need to verify that the coupling nut is tight.**
